# ON LINE

Published by CH MurphylClark-Ullman, Inc.

Spring, 1995

## HDPE Piping Job Requires Special Expertise

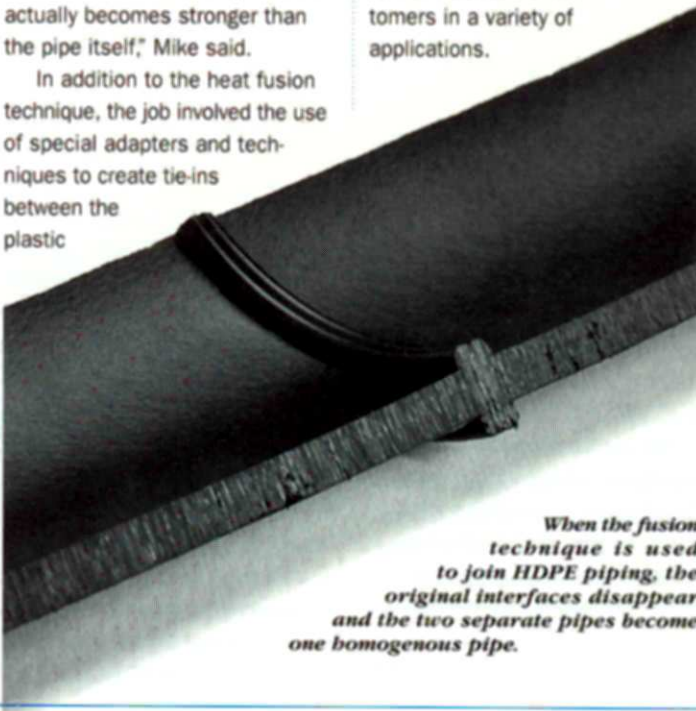
*When the fusion technique is used to join HDPE piping, the original interfaces disappear and the two separate pipes become one homogenous pipe.*

Due to its unique properties, the plastic piping must be connected through a process called heat fusion, using a special piece of equipment. The procedure involves heating two surfaces to a specified temperature to soften the material, then joining them together by force.

The fusion procedure causes a flow of molten material on both surfaces. The material mixes and then fuses when pressure is applied. The pipe joints are allowed to cool, and the molecular structure of the plastic changes back to its solid form.

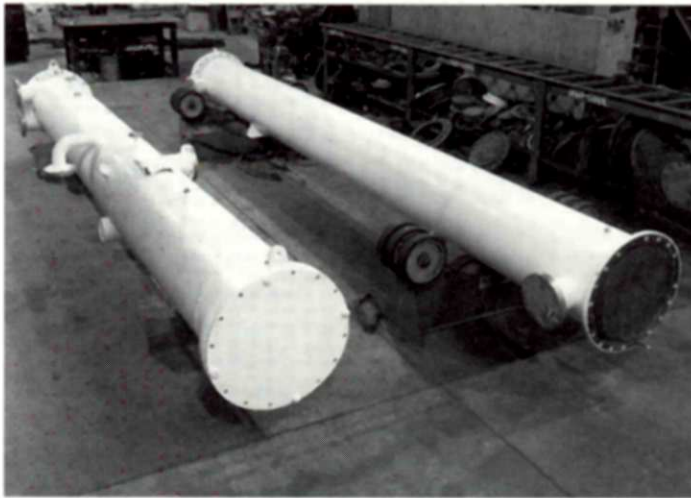
We retubed these two heat exchangers for the Georgia-Pacific pulp and paper mill in Bellingham, Washington. One is a freon condenser (left) containing over 350 3/4-inch diameter copper tubes. The other is an acid cooler, which has 294 3/4-inch diameter tubes made of carbon steel.

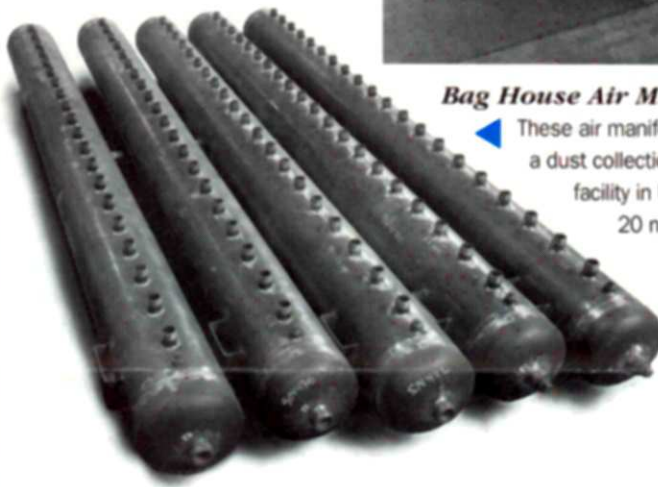
These air manifolds are among a dozen that we fabricated for a dust collection system being installed at a manufacturing facility in Ulysses, Kansas. Designed with approximately 20 nozzles each, the 12-foot long by 12-inch diameter manifolds met all ASME codes and were built to customer specifications using carbon steel construction.
